Joint Network Secretariat Urgent Procedure Task Force “Extreme effects of thermal overload in special cases of freight operation

Final report –

**Part 3: Detailed information on the work of the
JNS task force**

02. February 2022

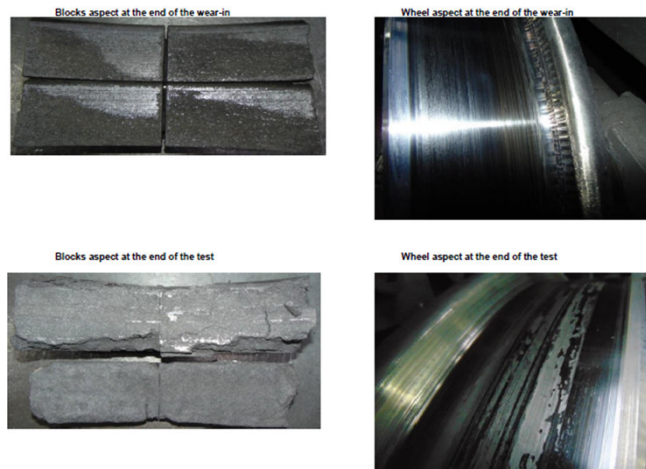
At temperature of approximately 700°C, significant increasing wear (self destroying) and in parallel decreasing temperature of the wheel

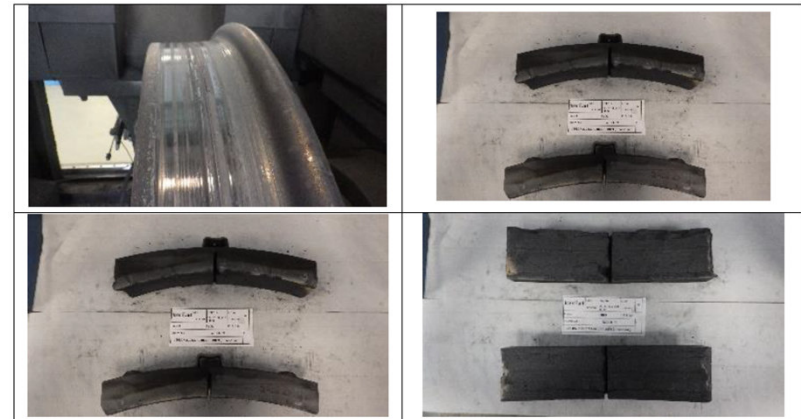
At temperature of appr 400°C, significant increasing wear up to max value of 16 mm, at that time the average wheel temperature is approximately 700°C

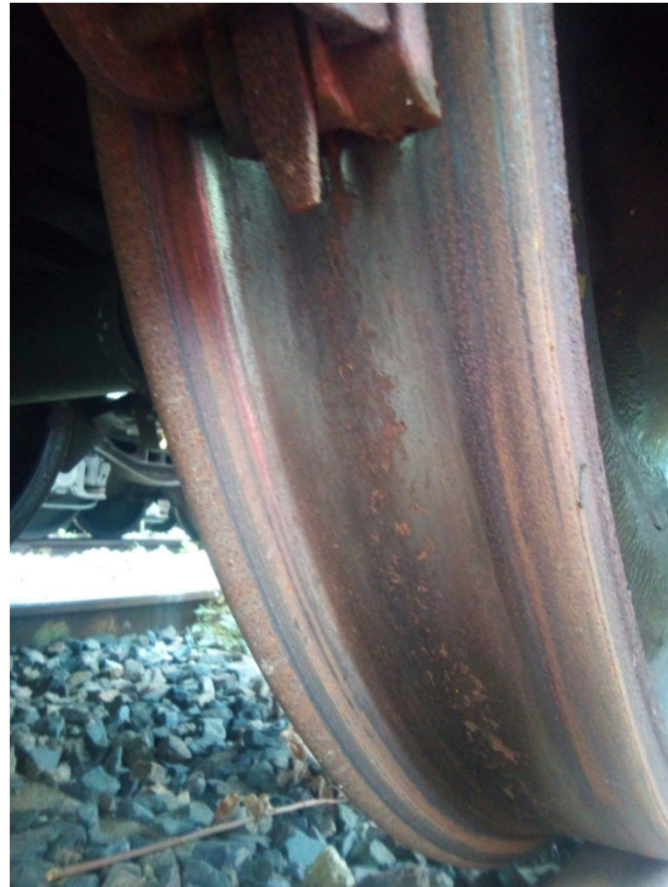
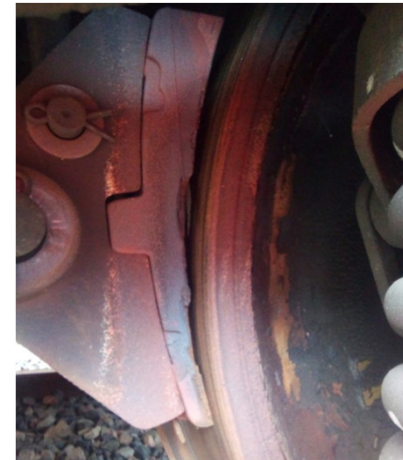
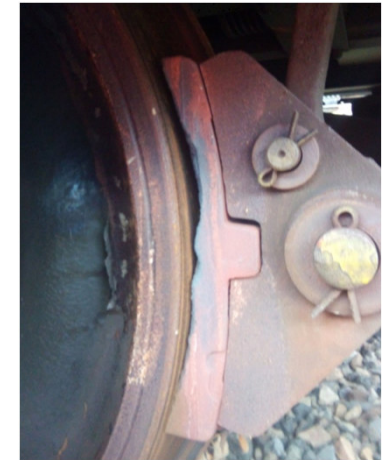
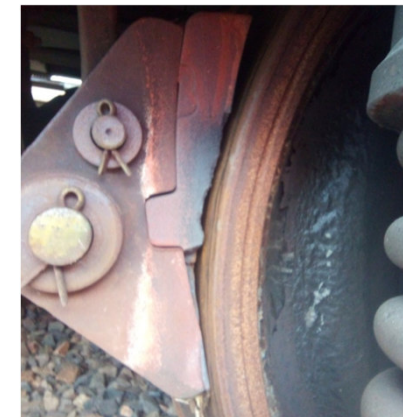
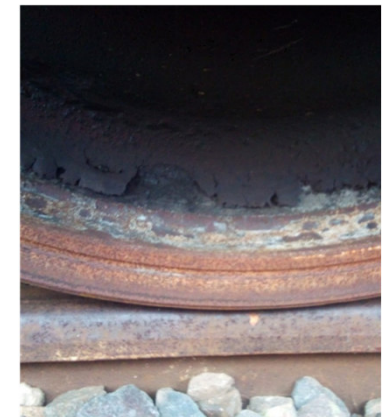
EXAMPLE: CAST-IRON #1

- Significant thermal overload
- Impact on the blocks
- Impact on the wheels (web and treads)

This incident has generated **sparkling + smoke + fire** along the track

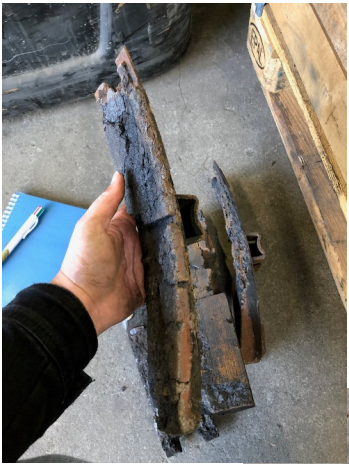
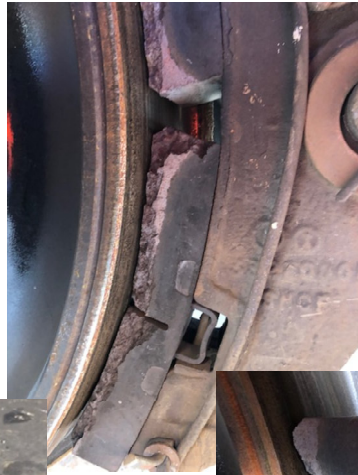
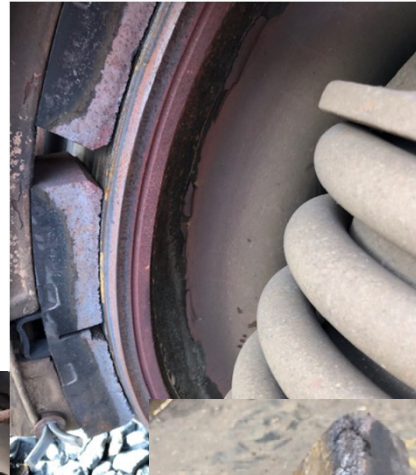
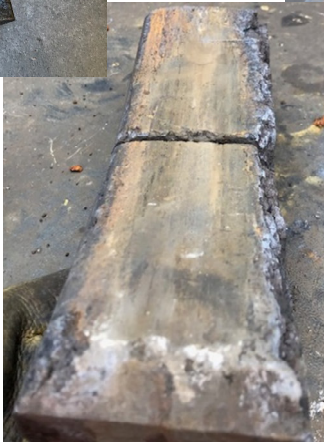
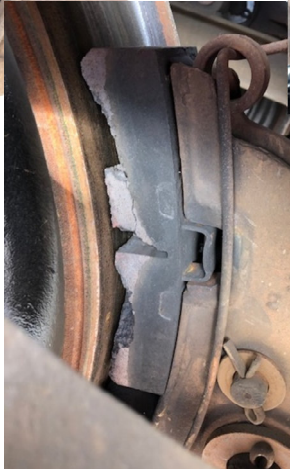
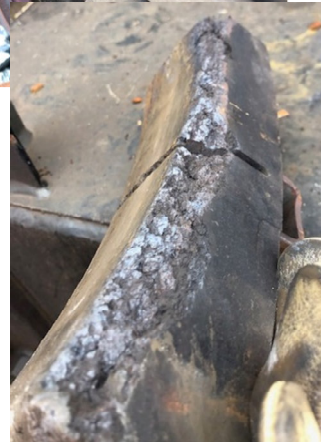
PARTICULAR BEHAVIOR OF IB 116*

All IB116*
after
unintended
brake
applications

Singular behavior noticed

- Behavior was analyzed
- To be kept in mind that the block has to destroy itself during the fixed brake
- Seems unusual (does not “only” wear)
- Damages on the brake block and signs of thermal overload on the wheel

**Needs to be further investigated
(normal procedure)**

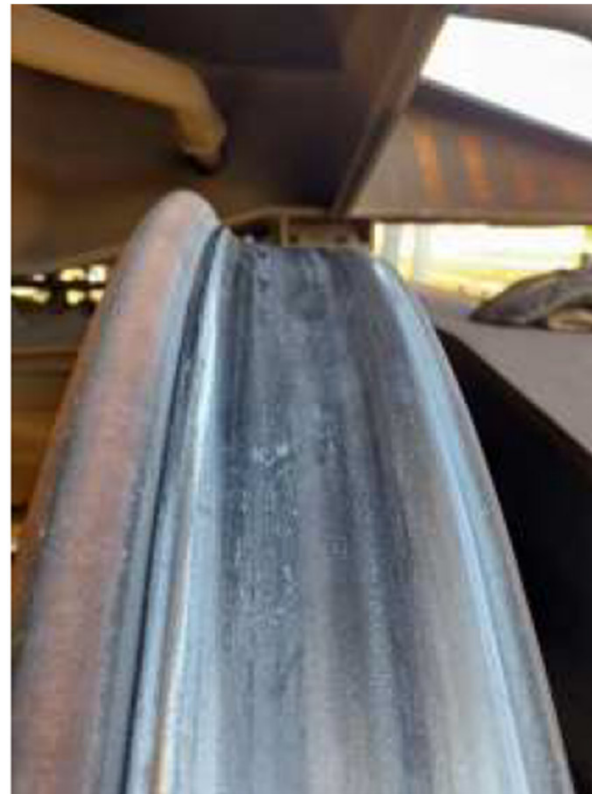
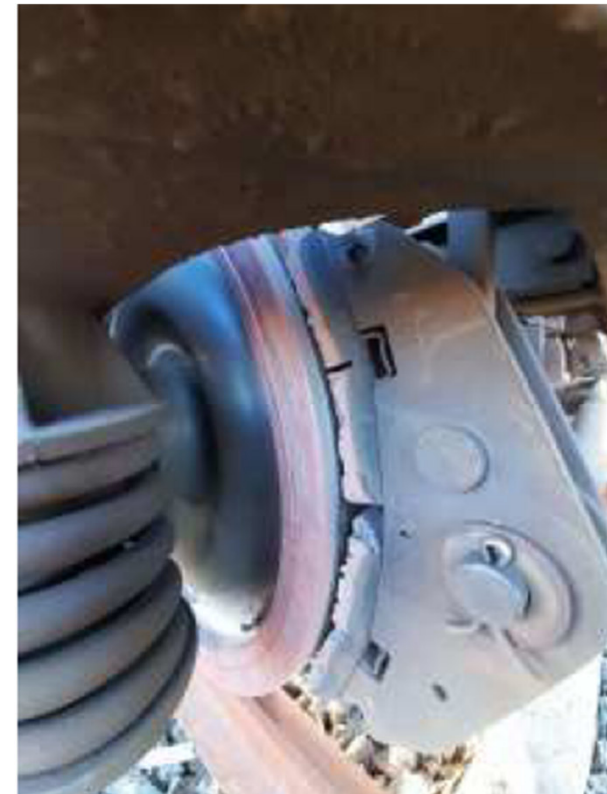
CASE 17 “2021-04-02_56440_SARZANA_MIR”

- Keeper : VTG Rail Europe
- wheel damage is categorized as “2” after evaluation based on the photos in part 2 about the extraordinary deformations
- Extraordinary wheel tread deformation near the flange

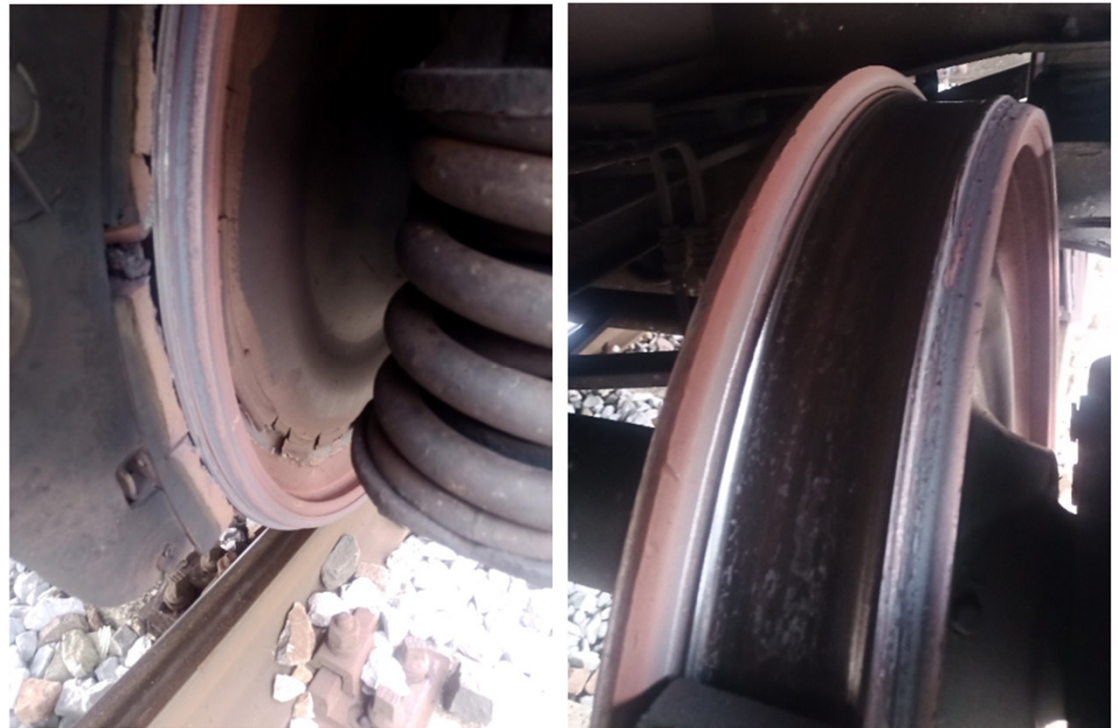
CASE 23 “2021-06-07_44235_CARNIA_MIR

- Keeper : Železničná spoločnosť Cargo Slovakia, a.s.
- Yes, wheel damage is to be categorized as “2” after evaluation based on the photos in part 2 about the extraordinary deformations
- Extraordinary wheel tread deformation near the flange and on the outer side of the tread
