Joint Network Secretariat Urgent Procedure Task Force “Extreme effects of thermal overload in special cases of freight operation

Final report –

**Part 3: Detailed information on the work of the
JNS task force**

02. February 2022

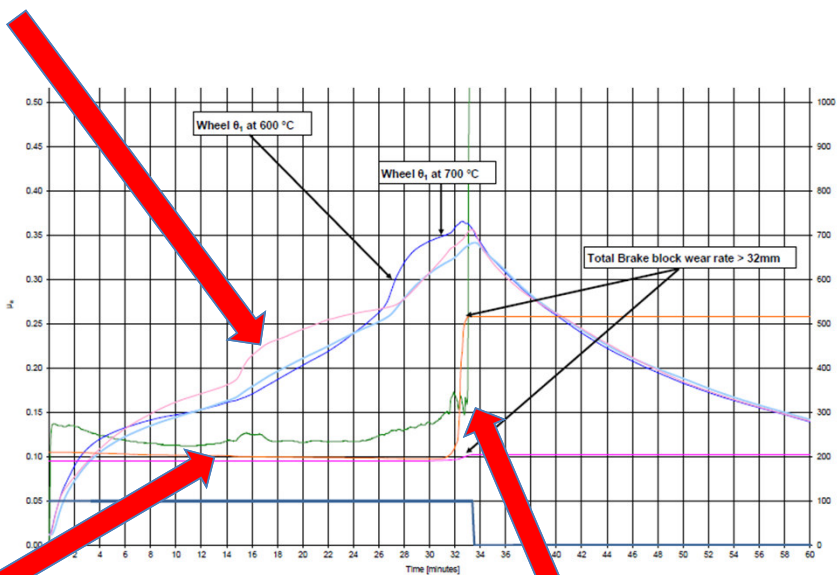
test program A6 of UIC leaflet 541-4 – example test result LL-block - type A

At temperature of approximately 700°C, significant increasing wear (self destroying) and in parallel decreasing temperature of the wheel

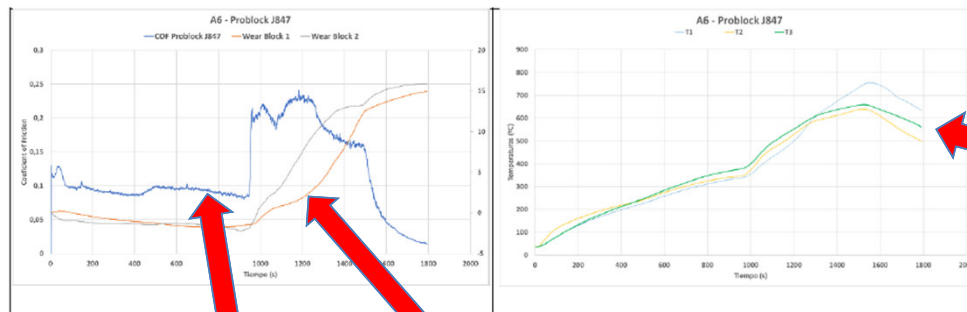
Locked brake testing test program A6 of UIC leaflet 541-4 – example test result LL-block - type B

At temperature of appr 400°C, significant increasing wear up to max value of 16 mm, at that time the average wheel temperature is approximately 700°C

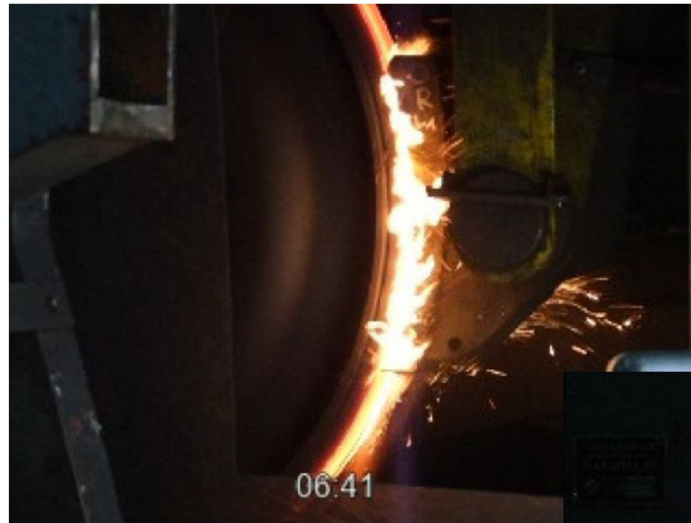
LL-Block
at max. fire state

- One is created by the brake blocks through radiant heat and open flames (yellow)
- Second due to the heating of the wheel tread (red)

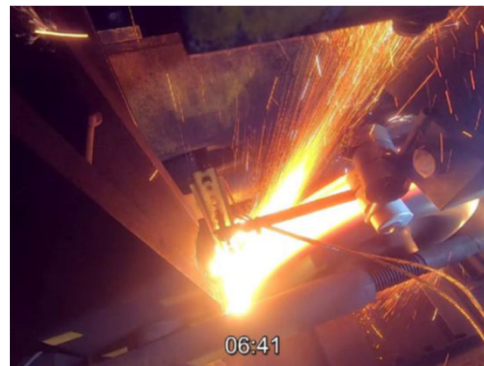
LL-Block

- The sparking of the rear brake direction of travel represents the main source for sparks. The sparks produced can occur at a distance of < 1 m from the point of spark formation in direct contact with the brake block.
- Possible burning materials may act as an ignition initiator. It is estimated that, in addition, the ignition effect of the sparks decreases considerably.

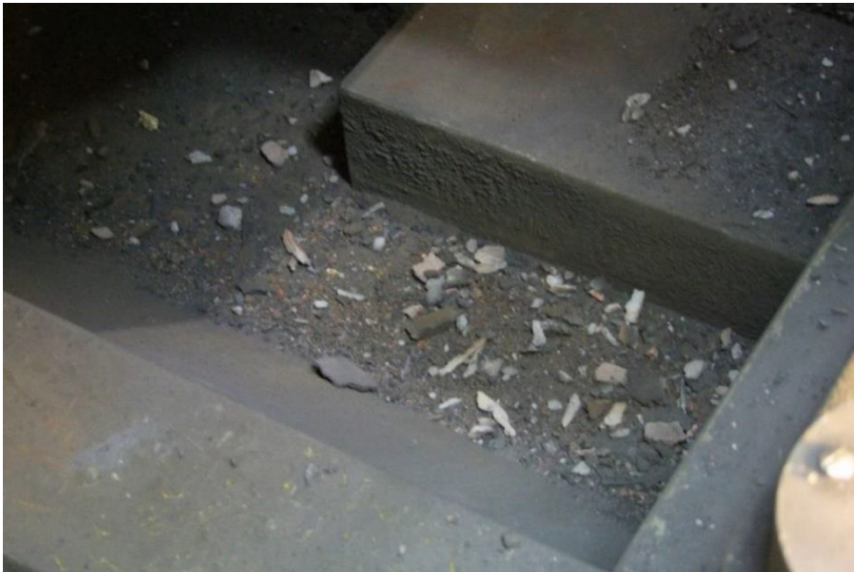
- The largely flaky material spalling from the burning brake blocks was examined. The fragments of the blocks had a maximum volume of 1 cm³. The fragments of CBB that were produced during the test were collected by the collection tray under the test stand.
- A spreading of the fragments beyond this was not detected. The ejection distance is therefore limited to the immediate vicinity of the braked wheel.

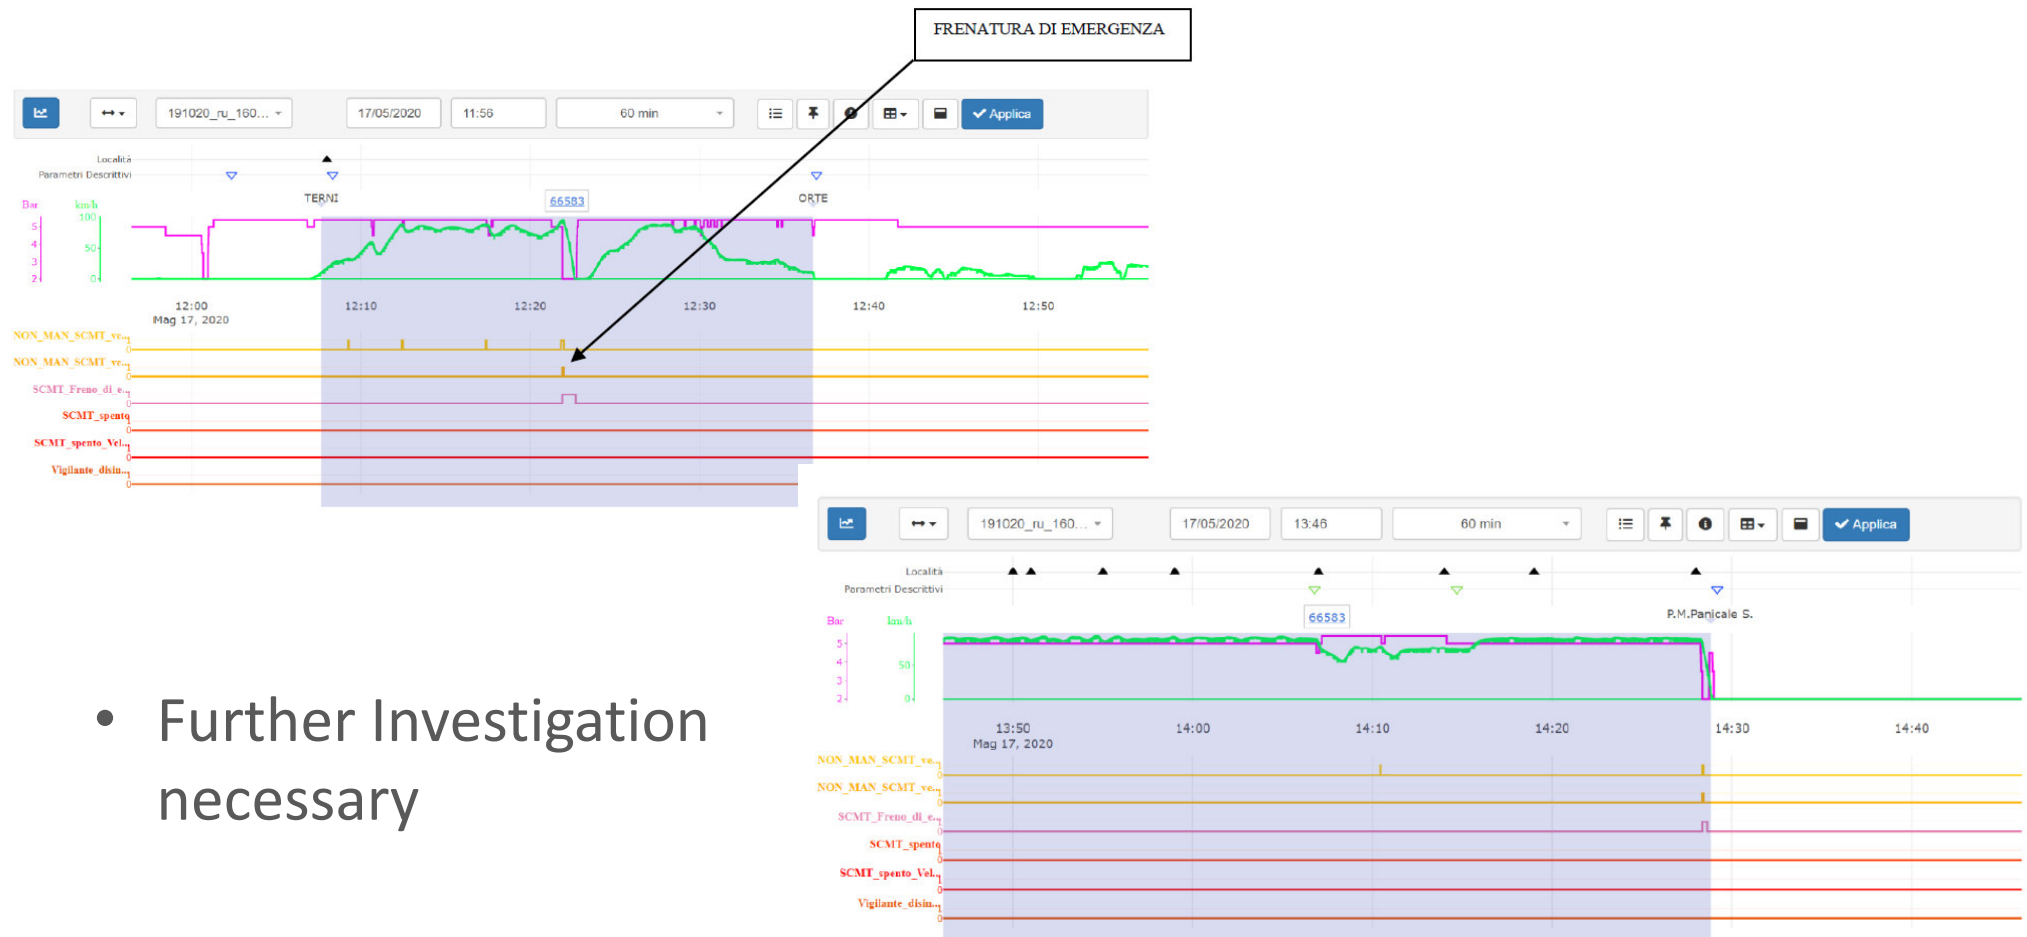
CASE 7 “2020-05-17_66583_PM PANICALE_DB”

- Keeper : DB Cargo Germany
- Derailment case.
- Yes, to categorize as “2” as the wheel is highly damaged.

Data analysed	Evidence collected	Evaluation
Brake system operation	Brake test report available	No abnormalities were found.
Bake system technic	Brake calculation available	No abnormalities were found.
Wheel investigation after incident	Special investigation report of the wheelsets available. 20-61015-TT.TVE33.2-14-001-Entgleisung It.	Thermal overload of the wheel Extraordinary wheel tread deformation with finally derailment
Running of the train	Automatic traction/braking system used for this event. <i>(the automatic system uses both electric and pneumatic braking).</i>	Strange behavior for example regarding the BP pressure evolution. Does not correspond to the normal behavior of a loco driver. Chaotic brake application and release orders.
Maintenance History	Maintenance data	No abnormalities were found.
Infrastructure (IS) detection systems	Data of the wheel detector systems	the last hot wheel detector met by the train before the derailment occurred registered a temperature of the wheel between 296° and 318° C. (see short-term risk control measure 2.2.1)

- ➔ Interaction Wheel / brake block needs to understand what exactly leads to such a picture of damage.
- ➔ By the elements collected on the event, there is no evidence that the case is directly related to IB116* issue and could occur with different brake blocks.

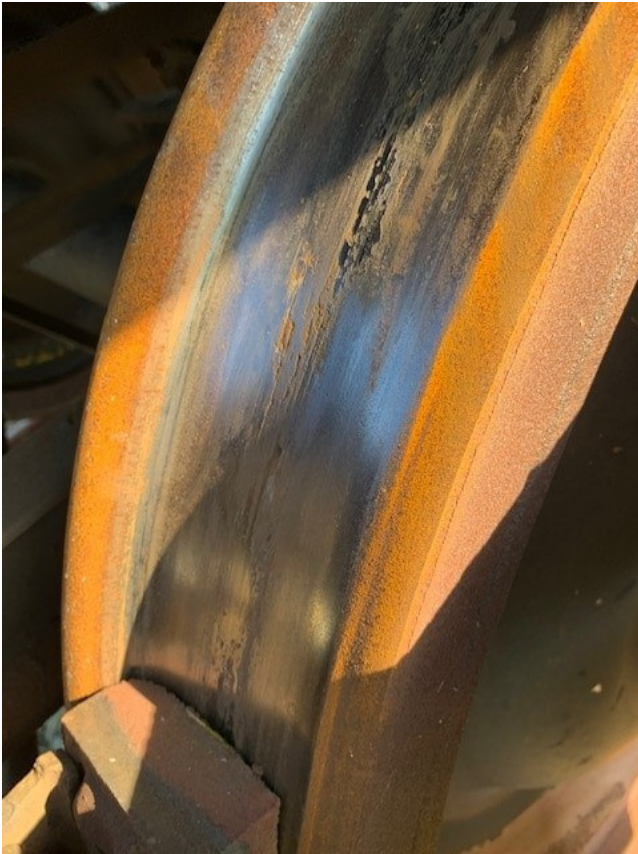
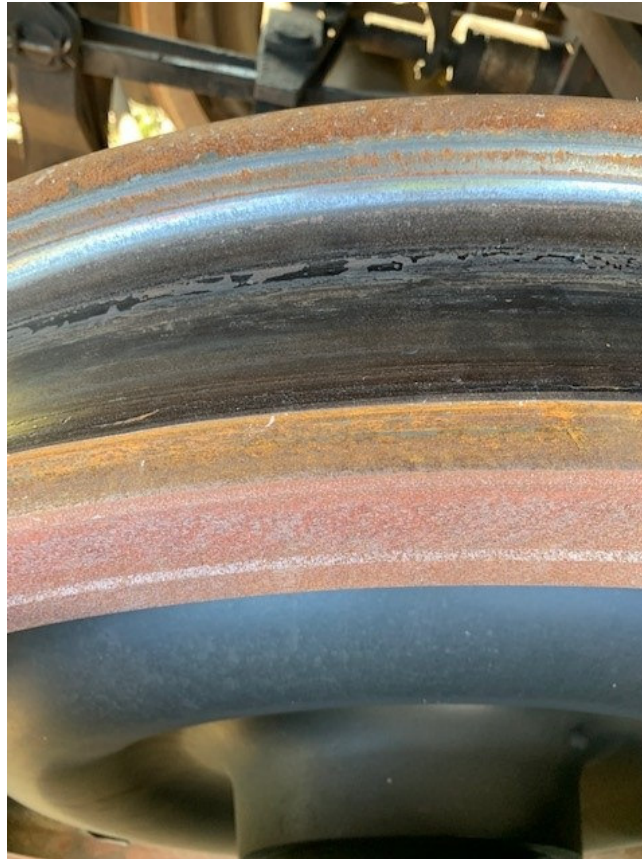
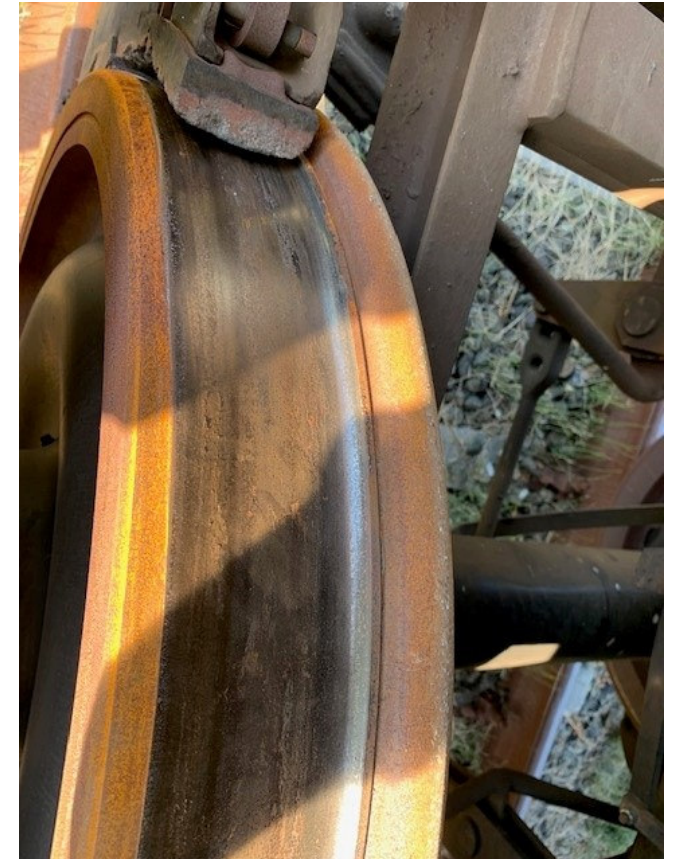
CASE 17 “2021-04-02_56440_SARZANA_MIR”

Wheelset without extraordinary wheel tread deformation

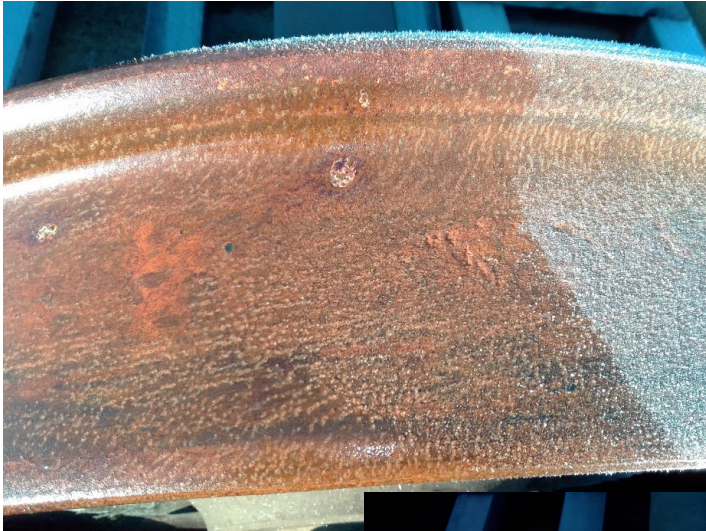
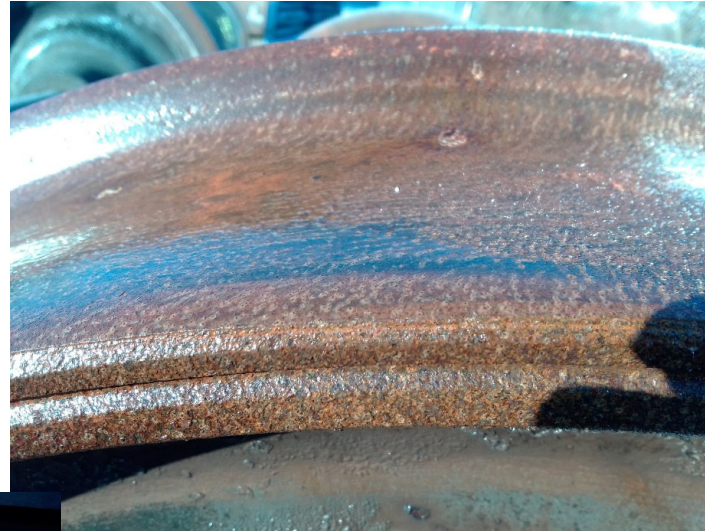
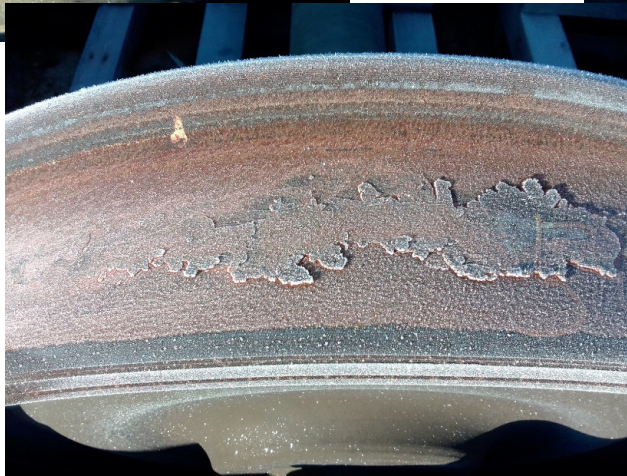
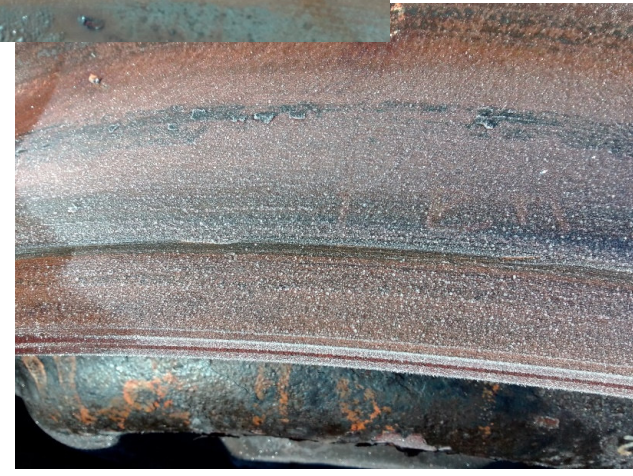
CASE 28 "2021-0729_63842_SPRESIANO_CAPTRAIN"

data analyzed	Evidence collected	Evaluation
Brake system operation	Brake test report available	Abnormalities detected. (Release function)
Bake system technic	Brake calculation available	No abnormalities were found.
Wheel investigation after incidence	Only based on pictures	Categorized „1“
Running of the train	Template LL Analysis	No automatic traction/braking system used for this event.
Maintenance History	n. a.	
IS detection systems	n. a.
